EAST HAVEN, CONNECTICUT

GARNISS POND DAM
CT-00114

NATIONAL DAM INSPECTION PROGRAM
CORPS OF ENGINEERS

Graniss Pond Dam
TR - Farm River
East Haven, Connecticut
CE# 27 660 KD
DATE 9/18/79 PAGE C-1

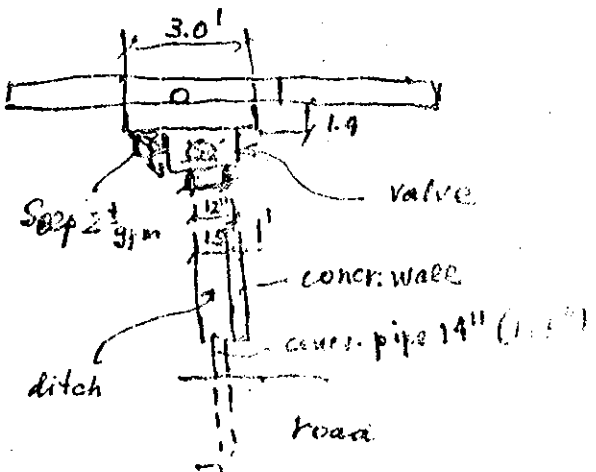
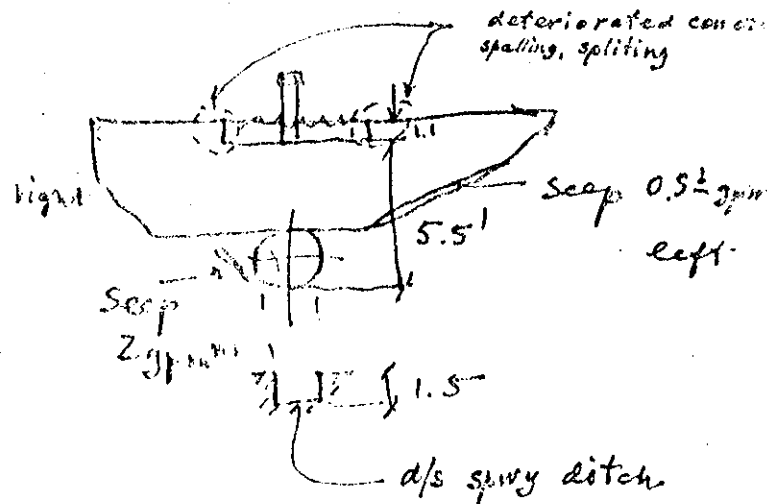
The findings of our visual inspection revealed that the condition of the dam is poor. The upstream weir is deteriorated and has fallen to a state of disrepair (Photo Page 3). The downstream weir has several areas of seepage at the downstream side (photo 5 and 6). The crest and slopes are overgrown with trees and brush (photos 1 and 2).
